**American Home Services**

Report # 11-6025

**BUILDING INSPECTION REPORT**  
**(Residential)**

Description: Single Family Residence  
Building faces: East

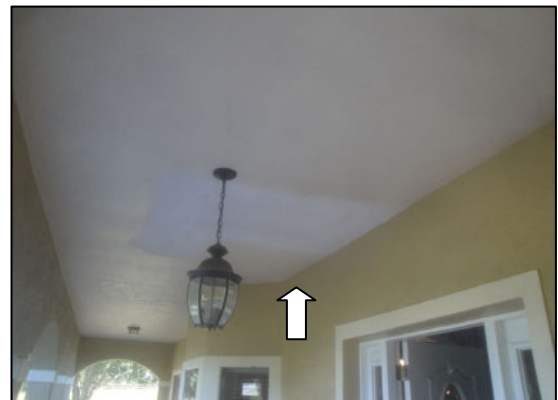
ceiling damage on front porch requiring repair/finish work

**Front porch ceiling has unfinished repair patches from roof leakage. Requires drywall repair.**

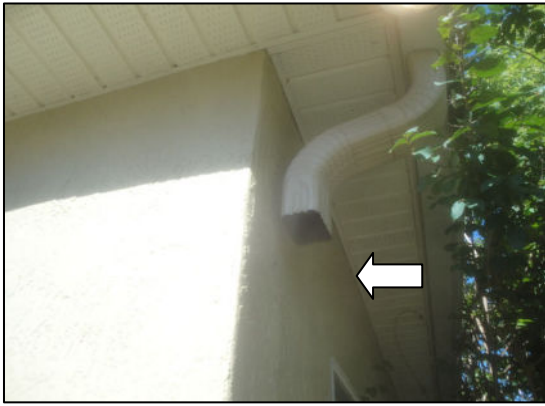
gutter not installed

**Gutter at rear is not installed. Requires repair.**

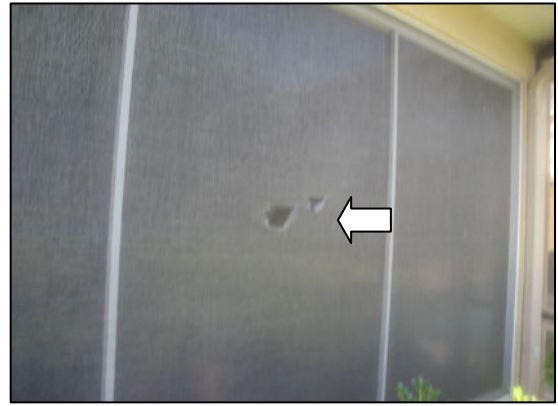
torn panels

**Rear porch has torn screen and window panels, requires repair.**

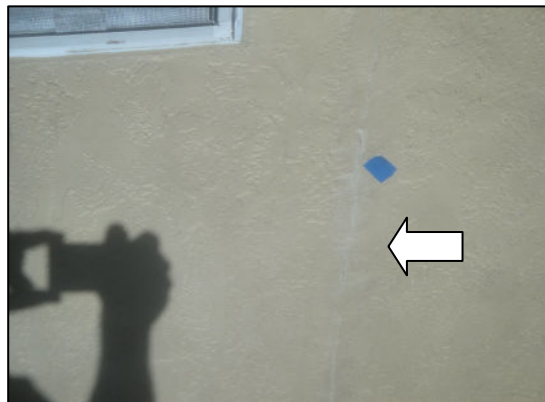
crack requiring sealing

**Crack is present at rear requires sealing.**

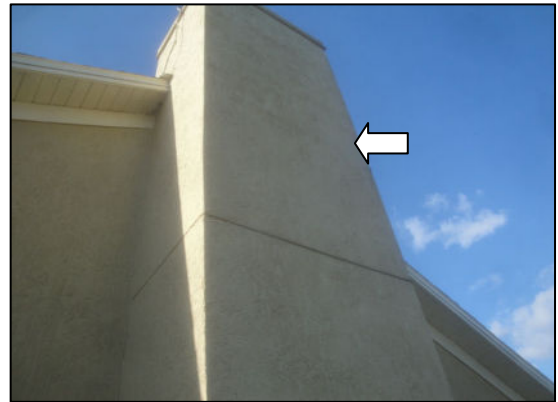
loose stucco requiring repair

**Crack at upper area of chimney exhibits loose stucco. Requires stucco repair.**

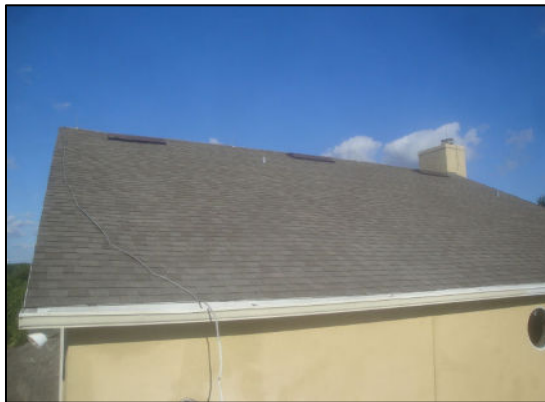
**Roof is in serviceable condition, with wear indicative of its age. Roof appears to be original. Life expectancy is approximately 10 years.**

shingles in fair conditin

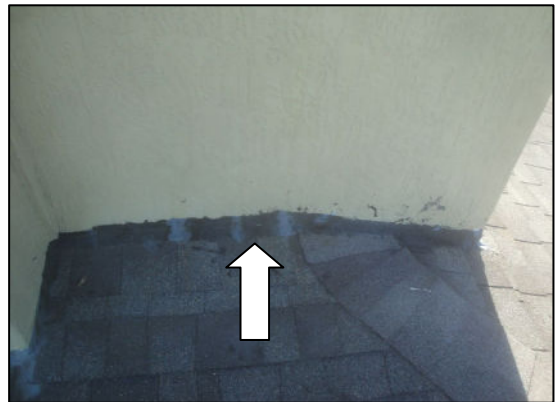
**Evidence of prior leakage is present in the form of tarred in flashing around front and right side of porch roof. Water damaged ceiling is below.**

tarred in flashing

**Recommend water testing to ensure leak is not active and repair appropriately.**

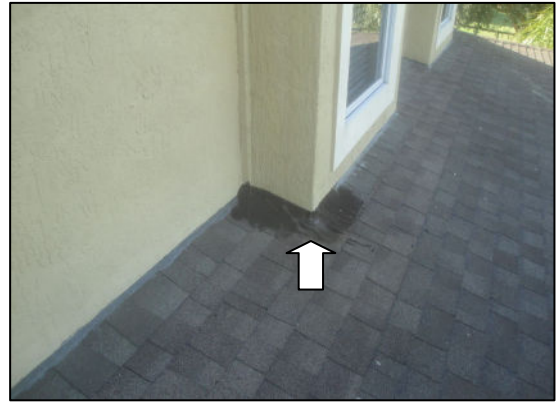
tarred in flashig

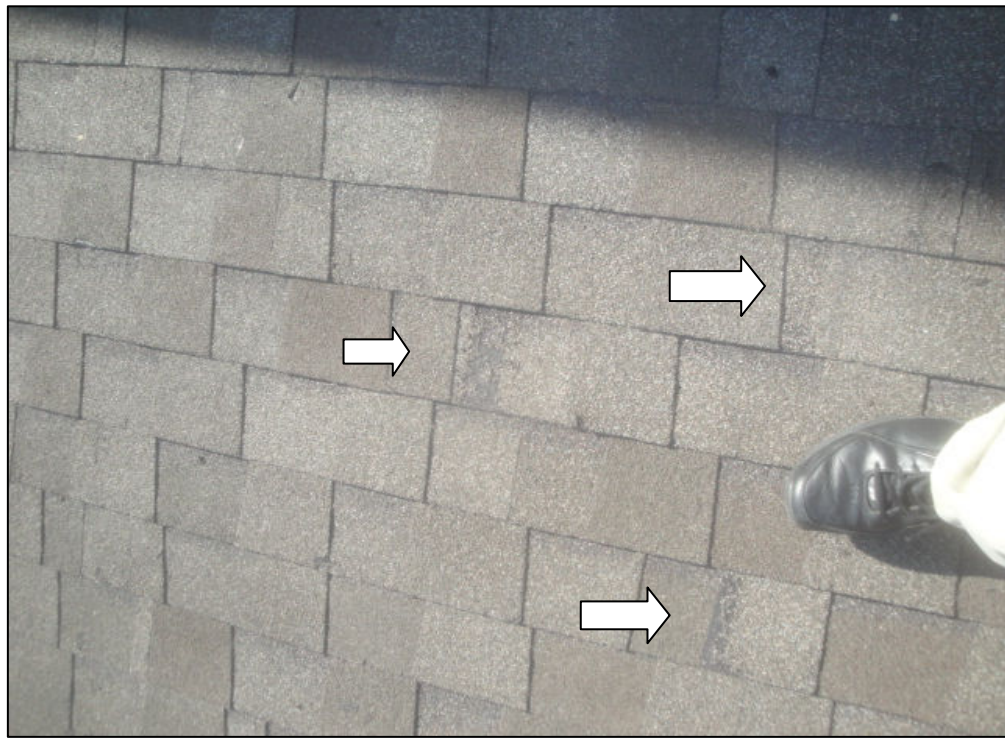
example of wear on shingles

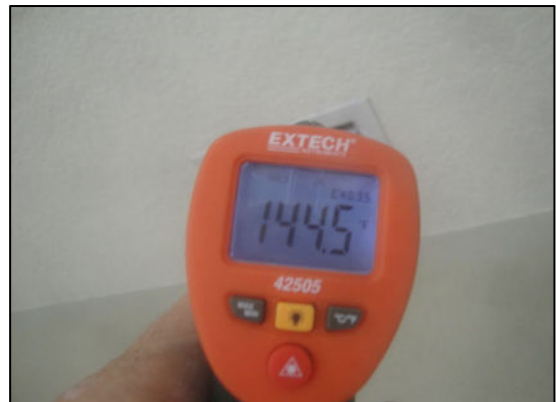
**Lower system did exhibit a minimum 15 degree temperature differential in heat mode but did NOT in cool mode. Requires further investigation/repair.**

temperatures recorded during heat mode

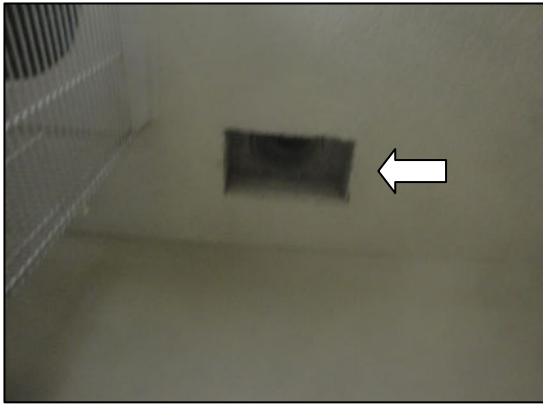
**Supply grill is missing in utility room. Requires installation.**

missing grill cover

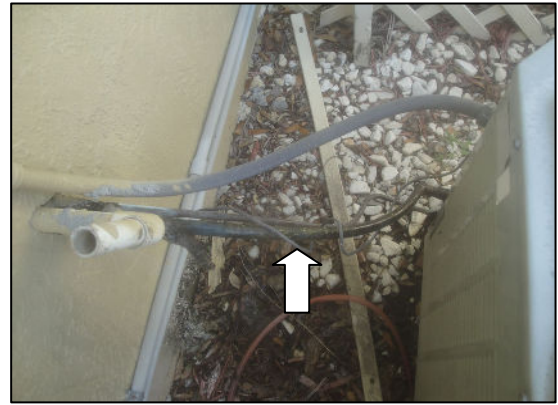
**Freon lines are not insulated, requires repair.**

missing suction line insulation

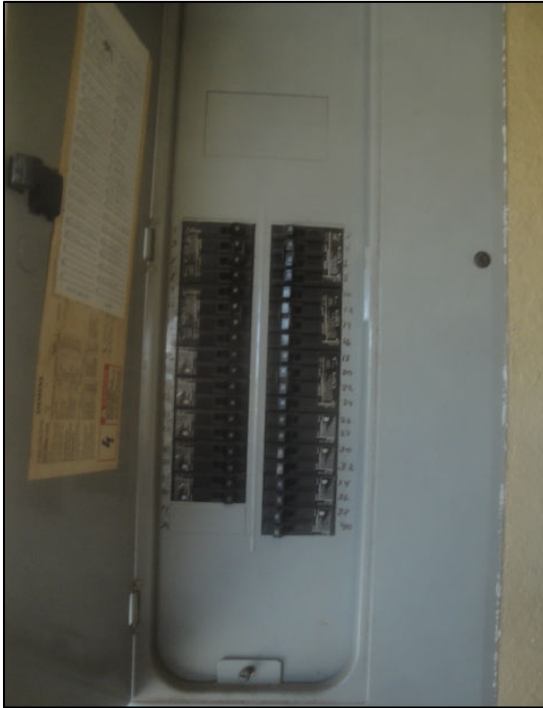
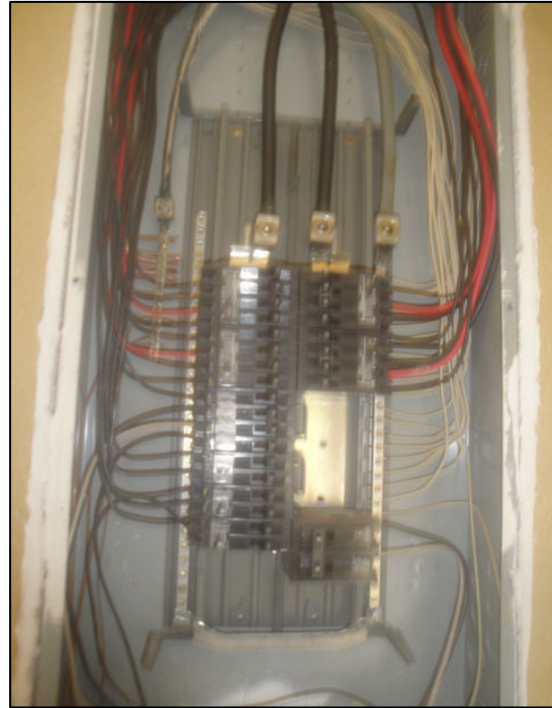
sub panel are in good condition.

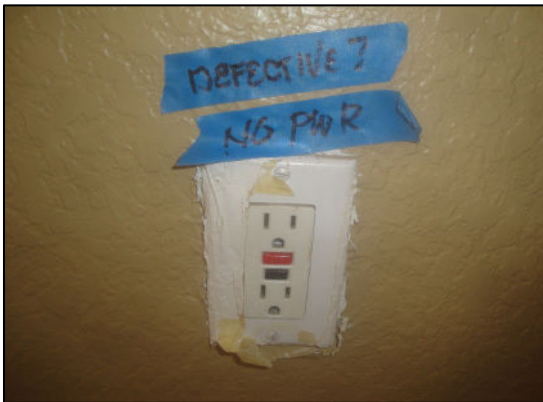
**Gfci receptacle in garage will not reset. Requires further investigation/repair.**

gfcı will not reset

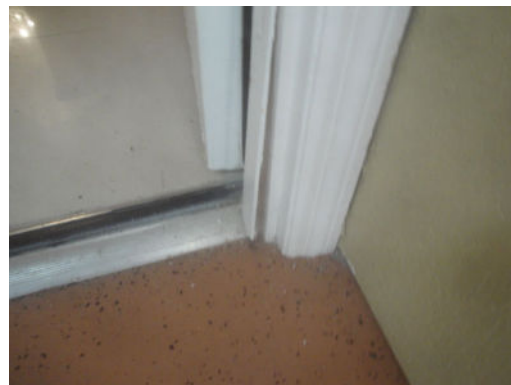
**Baseboards are missing at right side of garage.**

missing baseboards

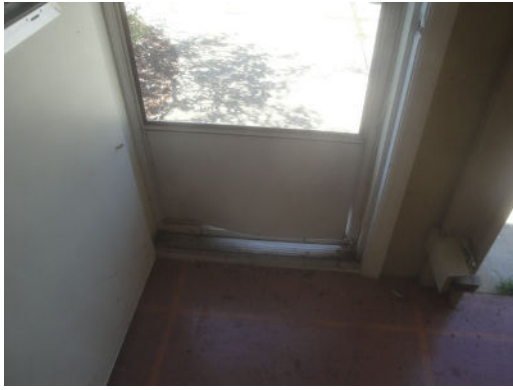
**Storm door at garage is damaged.**

damaged storm door

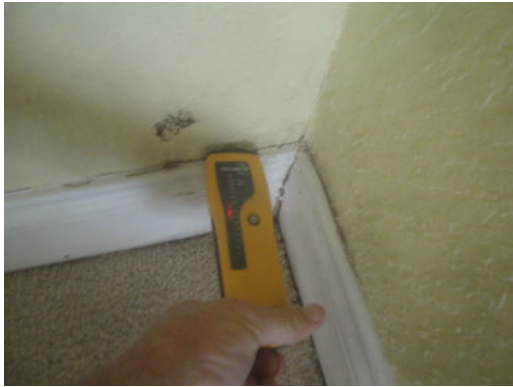
**Wall intrusion is present at corner in guest room. Moisture meter did indicate moisture in wall. Mold is present at wall. Requires further investigation to find source of leakage and mold remediation in this area.**

water intrusion/mold

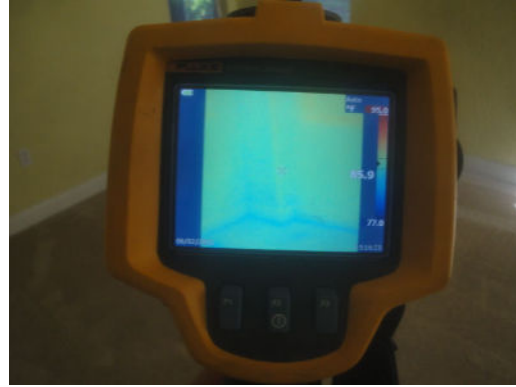
water intrusion at base

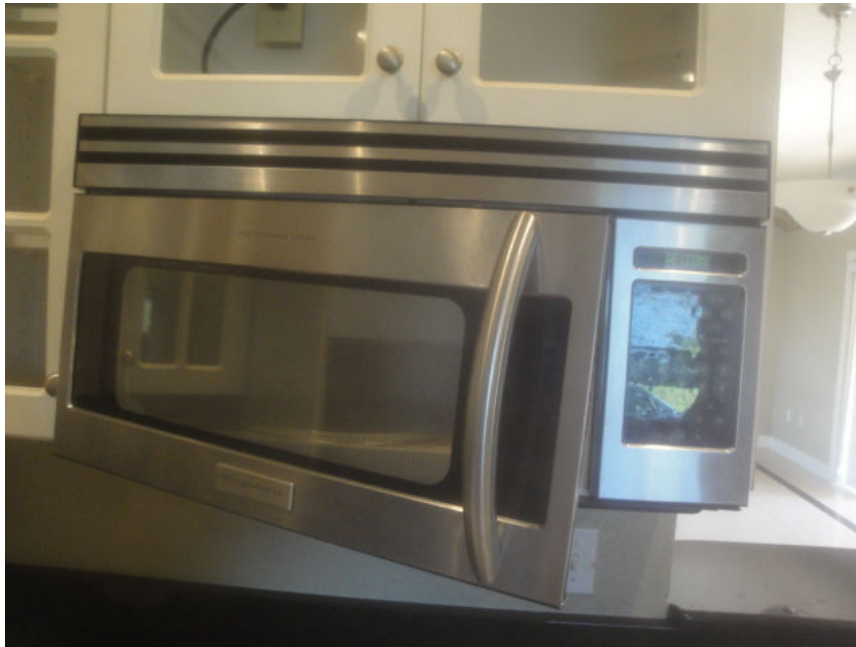
**Microwave door is damaged. Requires replacement.**

damaged microwave door

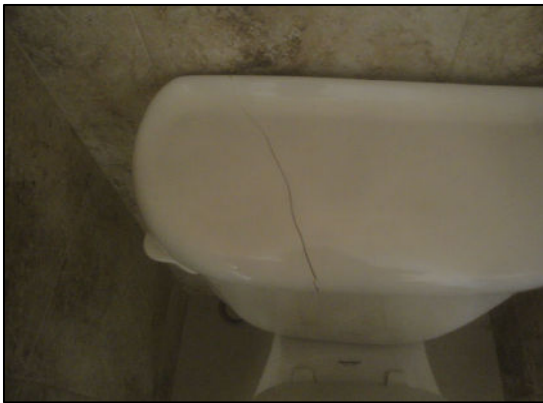
broken lid

**Water closet has broken lid / missing lid. Requires repair.**

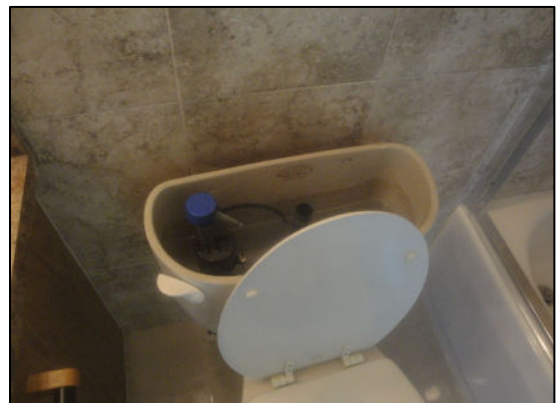
missing lid

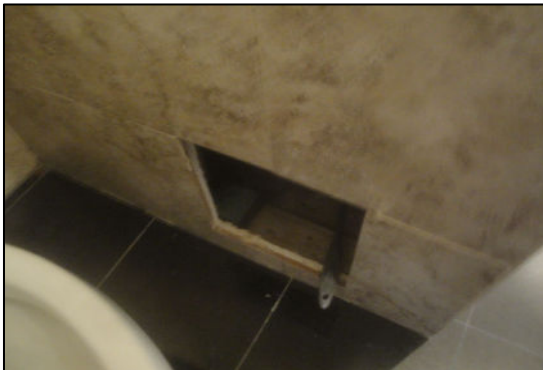
**Access door is missing at jecuzzi in master bath. Requires installation.**

missing acces cover panel

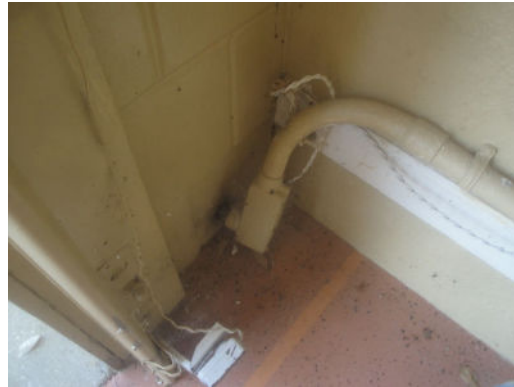
12 Irrigation system could not be operated due to dead receptacle at control panel.

conduit loose at control panel and wall

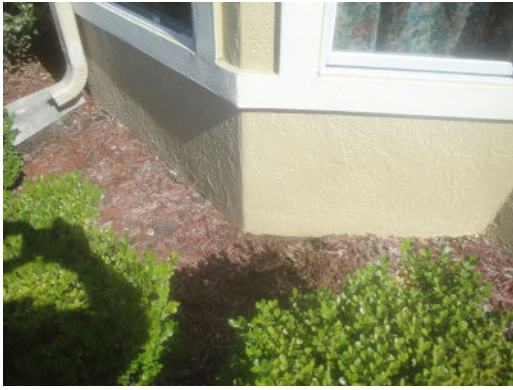
15 Soil is above grade at right side and rear perimeter. Recommend removal of soil above grade exposing foundation. Soil above grade is a conducive climate for subterranean termite intrusion.

soil below grade

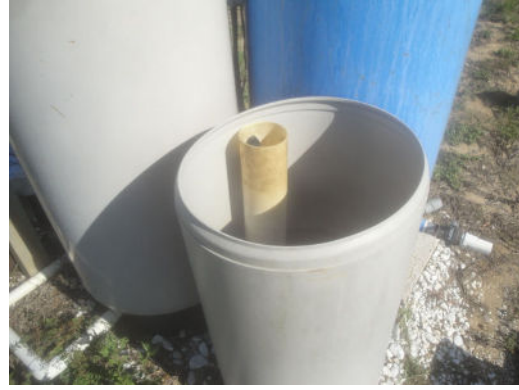
14 Covers are required at brine tank and chlorinator tank.

missing covers

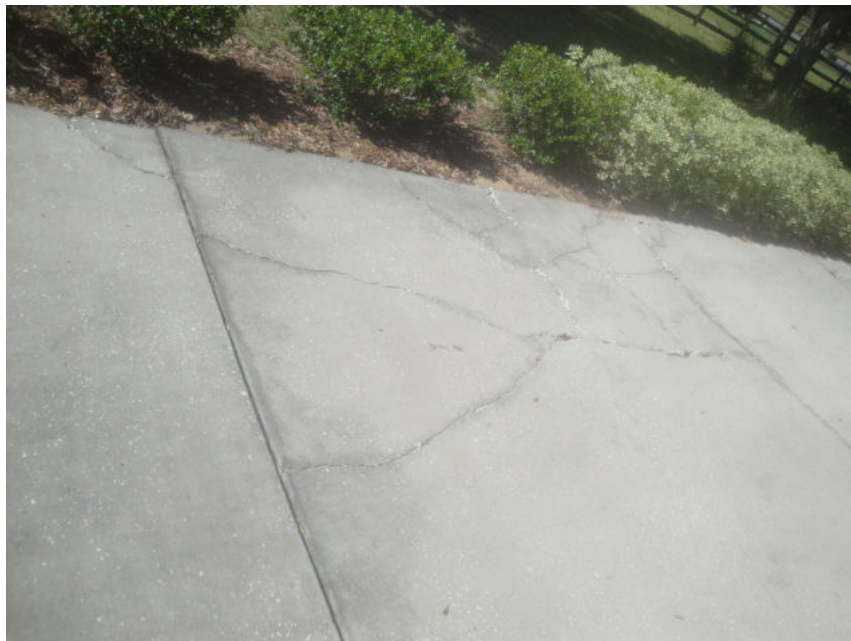
**Several areas of driveway requires repouring.**

area requiring repouring

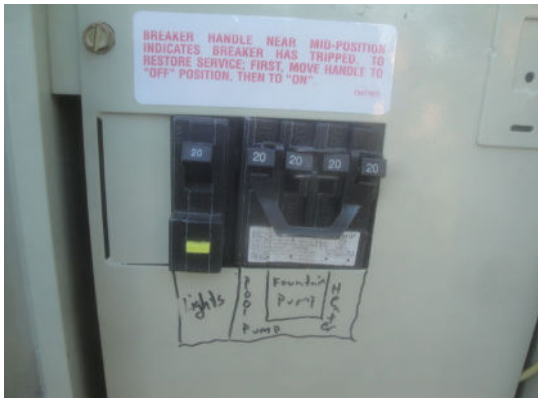
**Heater does not have its own breaker. Requires repair.**

pool heater not on separate breaker

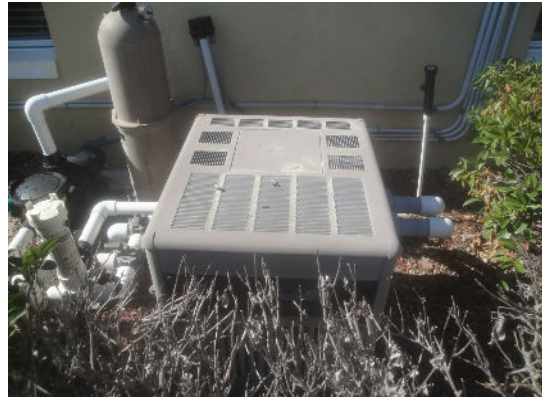
**Heater did not operate. Requires further investigation/repair.**

pool heater did not operate

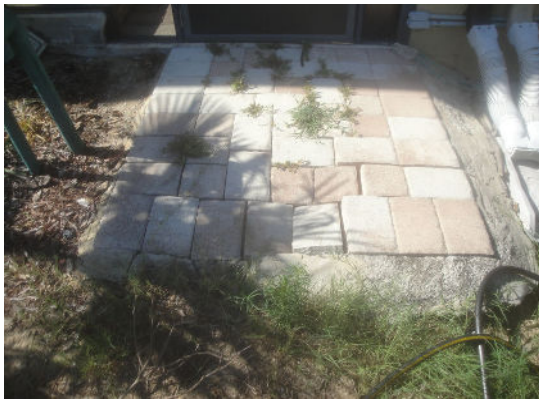
**Several areas of brick pavers have settled. Requires repair.**

brick pavers settling

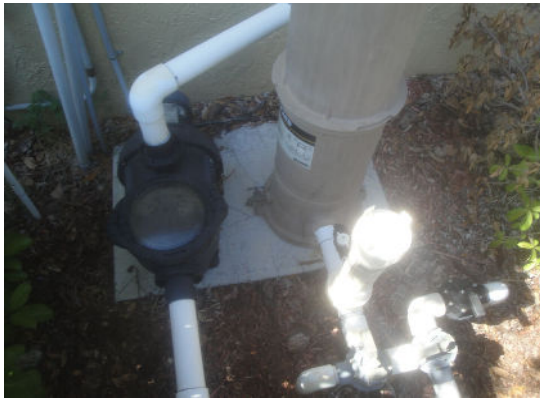
**Seal around basket strainer of pump is leaky. Requires new O ring.**

leaky seal at pump

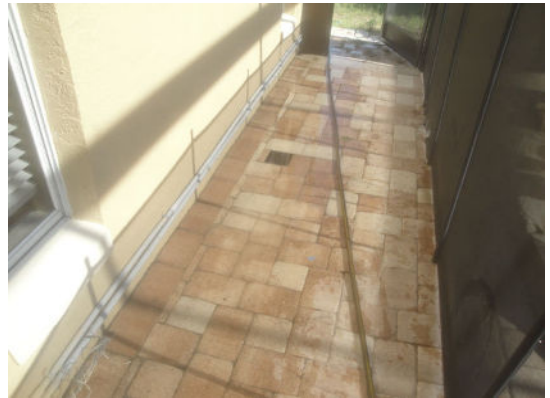
**French drain at left front did not perform well. Requires further investigation/repair.**

drain does not perform well

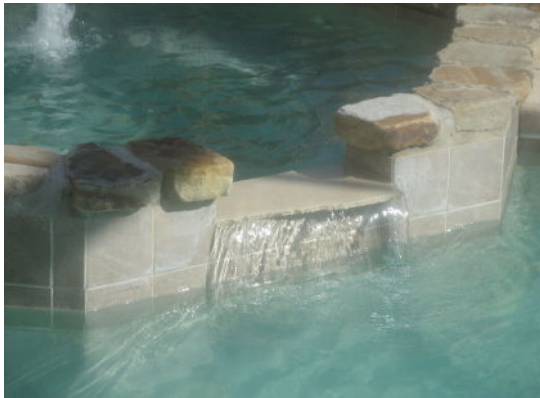
**Sill plate on jecuzzi is broken leaving sharp edges. Requires repair.**

broken sill plate
