**American Home Services**

Report # 11-6025

**BUILDING INSPECTION REPORT**  
**(Residential)**

Description: Single Family Residence  
Building faces: East

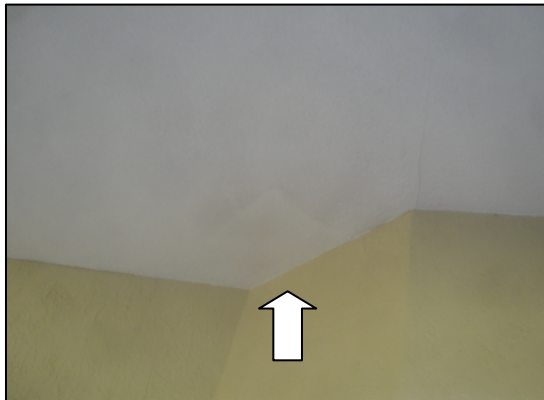
**Front porch ceiling has unfinished repair patches from roof leakage. Requires drywall repair.**

ceiling damage on front porch requiring repair/finish work

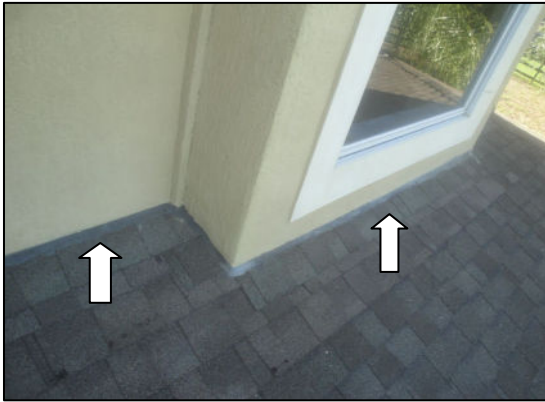
**Evidence of prior leakage is present in the form of tarred in flashing around front and right side of porch roof. Water damaged ceiling is below.**

tarred in flashig

**Recommend water testing to ensure leak is not active and repair appropriately.**

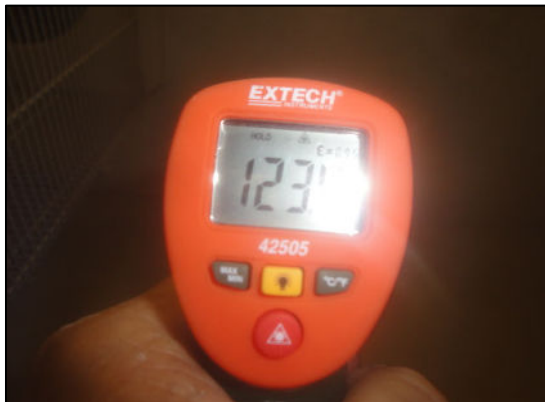
**Lower system did exhibit a minimum 15 degree temperature differential in heat mode but did NOT in cool mode. Requires further investigation/repair.**

temperatures recorded during heat mode

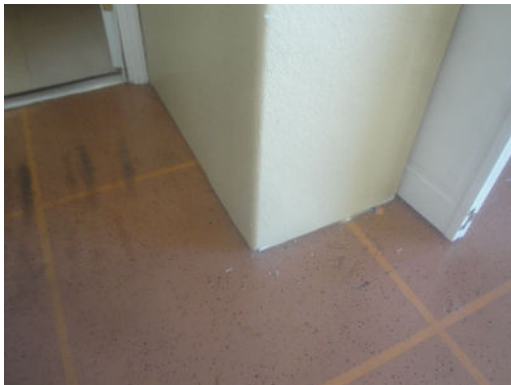
**Baseboards are missing at right side of garage.**

missing baseboards

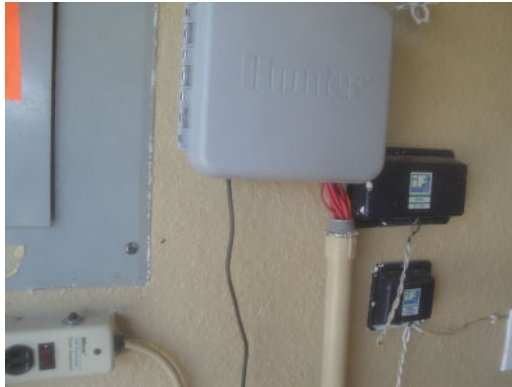
conduit loose at control panel and wall
